## West Side Fine Screens Building

The Fine Screens building at West Side was constructed in 1928, and is essential for operation of the Stickney WRP. It is a steel-frame building with masonry cladding. The District has invested substantial capitol funds into this building recently, including new sewage screens, new HVAC units, and a new roof and skylights.

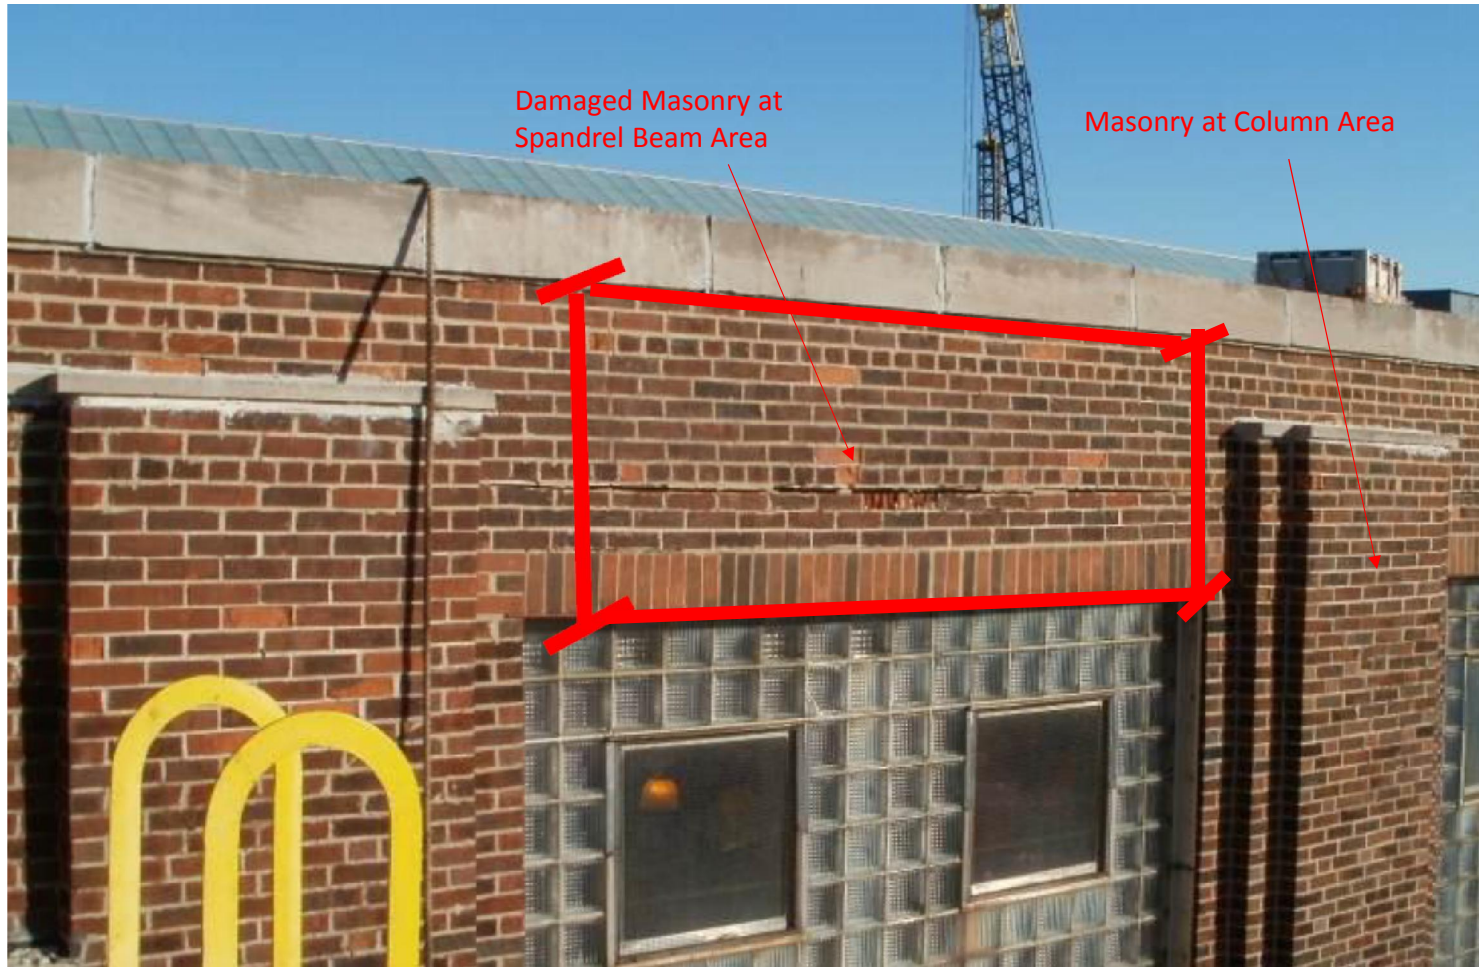
Damaged Masonry at  
Spandrel Beam Area

Masonry at Column Area

An assessment of the defective masonry at the existing Fine Screens Building was performed by consultant Klein & Hoffman in order to determine the scope of restoration work required. During initial inspection, masonry damage was only visible along the spandrel beams above the windows. Masonry at columns appeared to be in good condition. Therefore, inspection openings were only made along the spandrel beams.

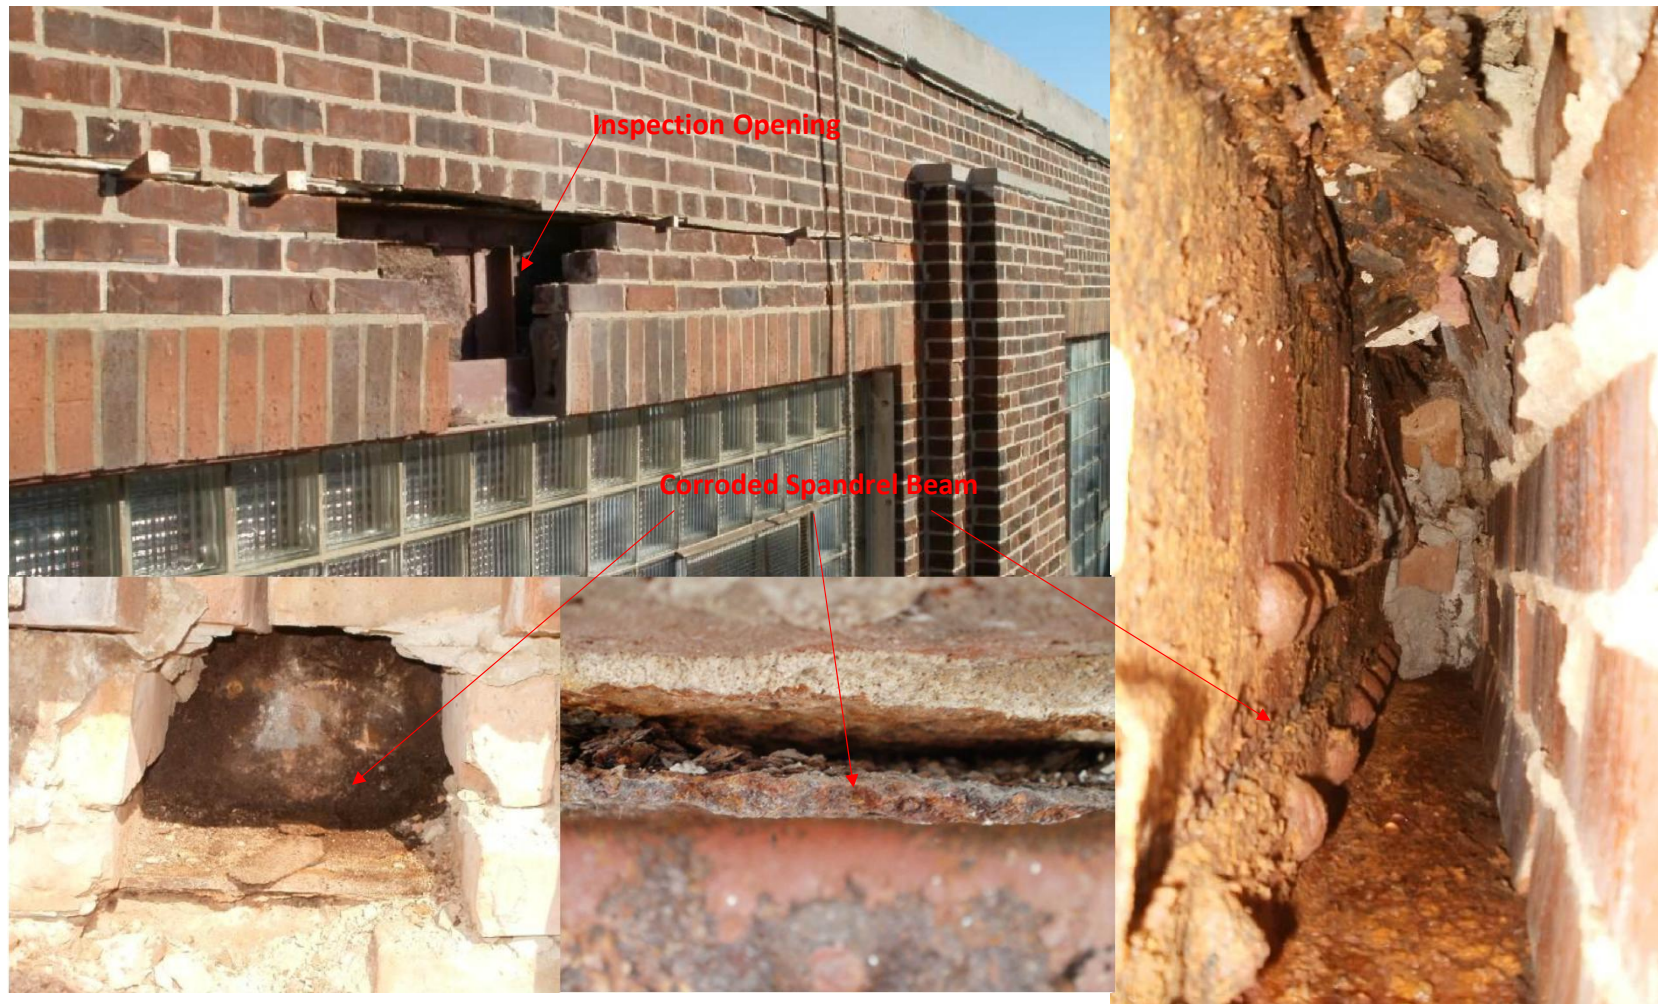
After looking inside of the inspection openings, it was confirmed that the spandrel beams were severely corroded and were causing the masonry damage. It was determined that the spandrel beams and all the masonry above the windows would have to be removed and replaced. This repair work would be performed in Contract 04-128-3P.

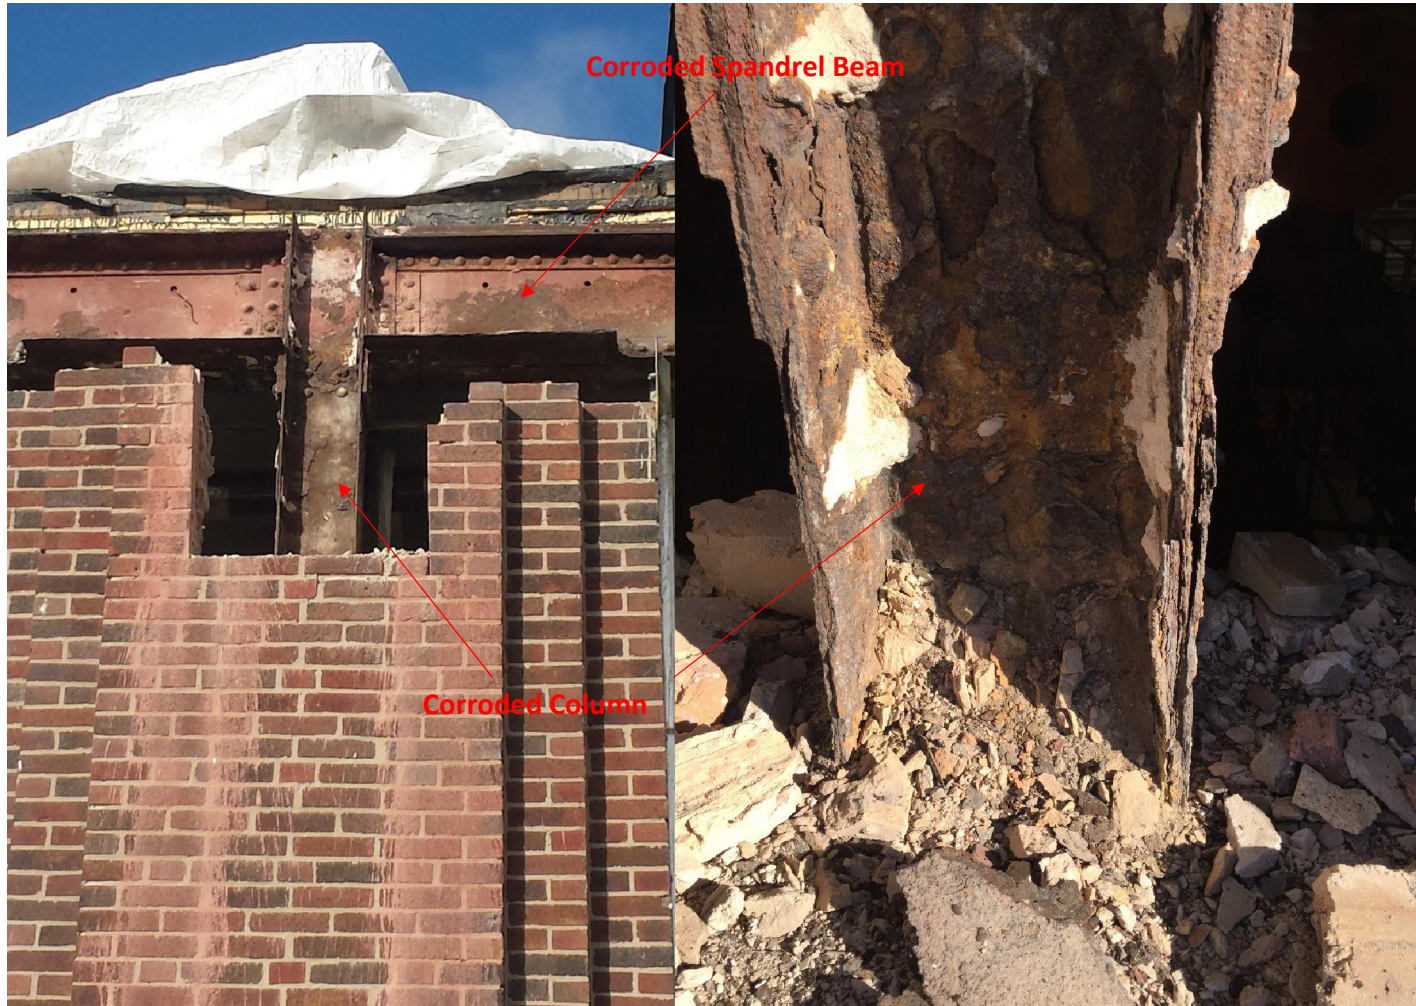
Once the repair work began on 04-128-3P, more masonry was removed in order to replace the corroded spandrel beams. When this masonry was removed, severe corrosion was also discovered on many columns. The cause of this corrosion was determined to be water leaking through the parapet and atmospheric moisture condensing on the columns, with no way for the water to get out.

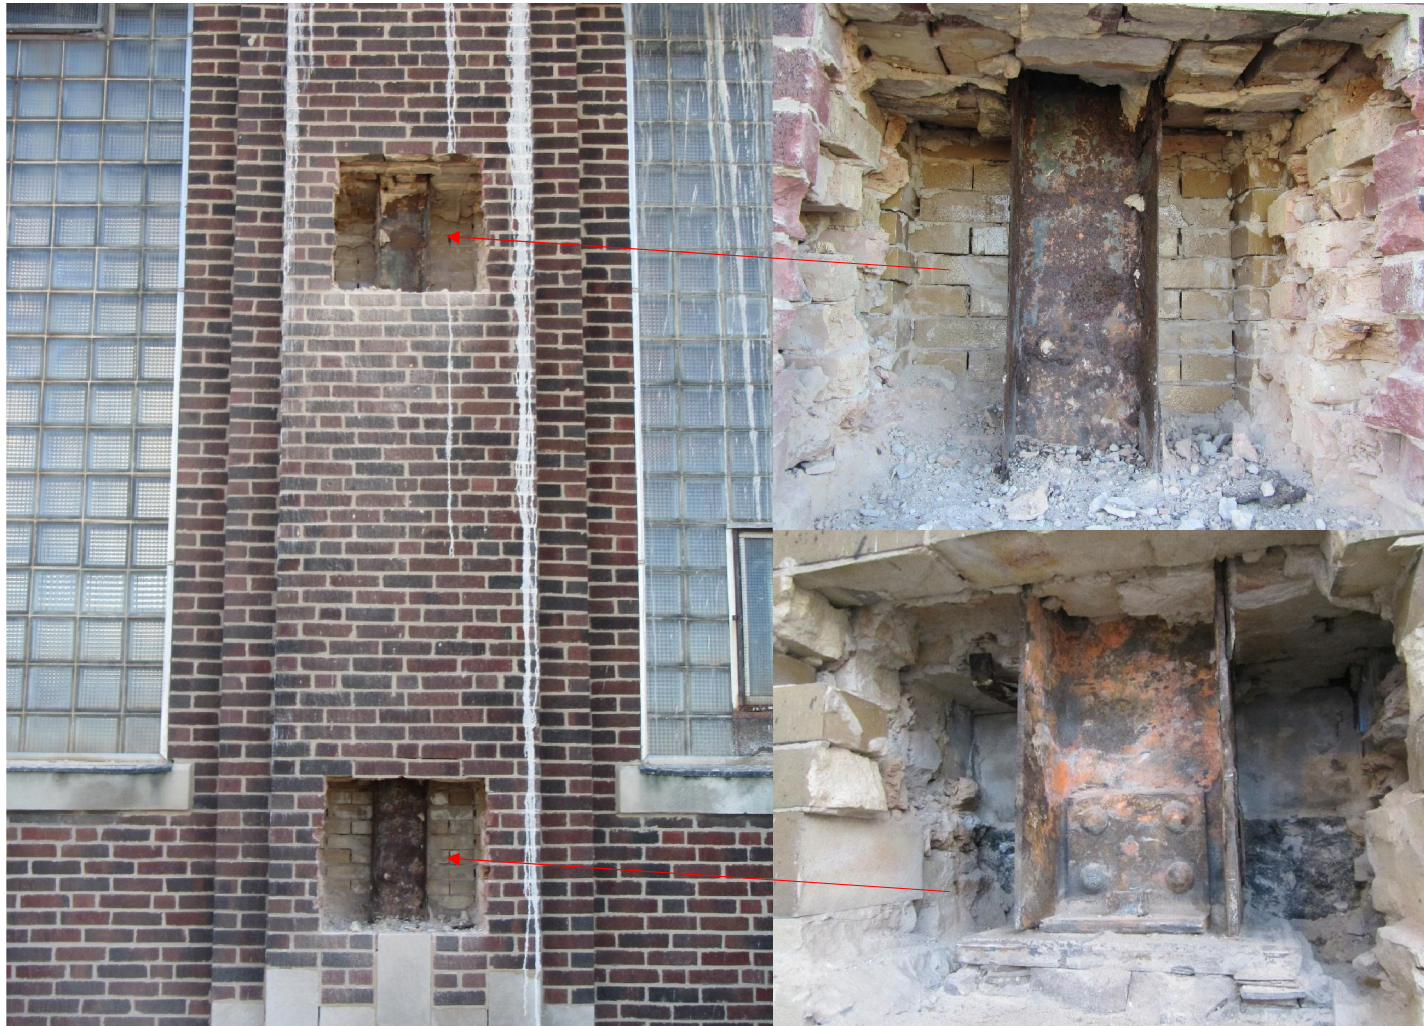
Additional openings were made and severe corrosion could be seen throughout the height of some columns. The Engineer determined that full height column repairs would be necessary for many of the columns

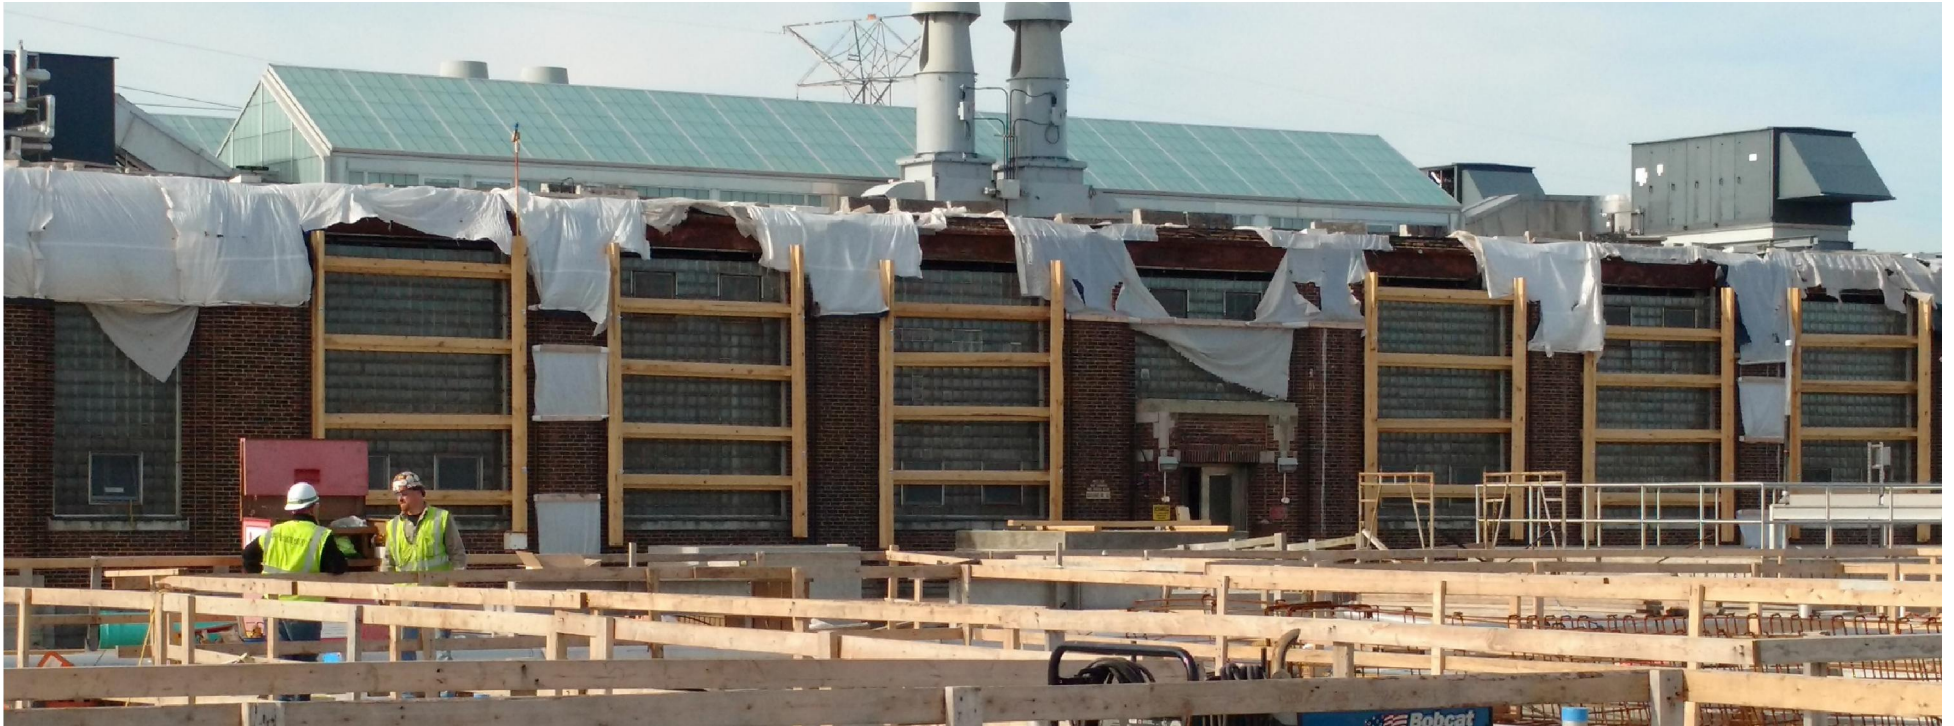
**North Elevation of Grit Chamber & Fine Screens Building**

The 32 columns are each approximately 20' tall. Each column will have to be exposed for its entire height in order to determine the complete scope of column repair work. This will require a significant amount of masonry removal, weather protection, and bracing to stabilize the masonry walls, glass block windows, and roof.

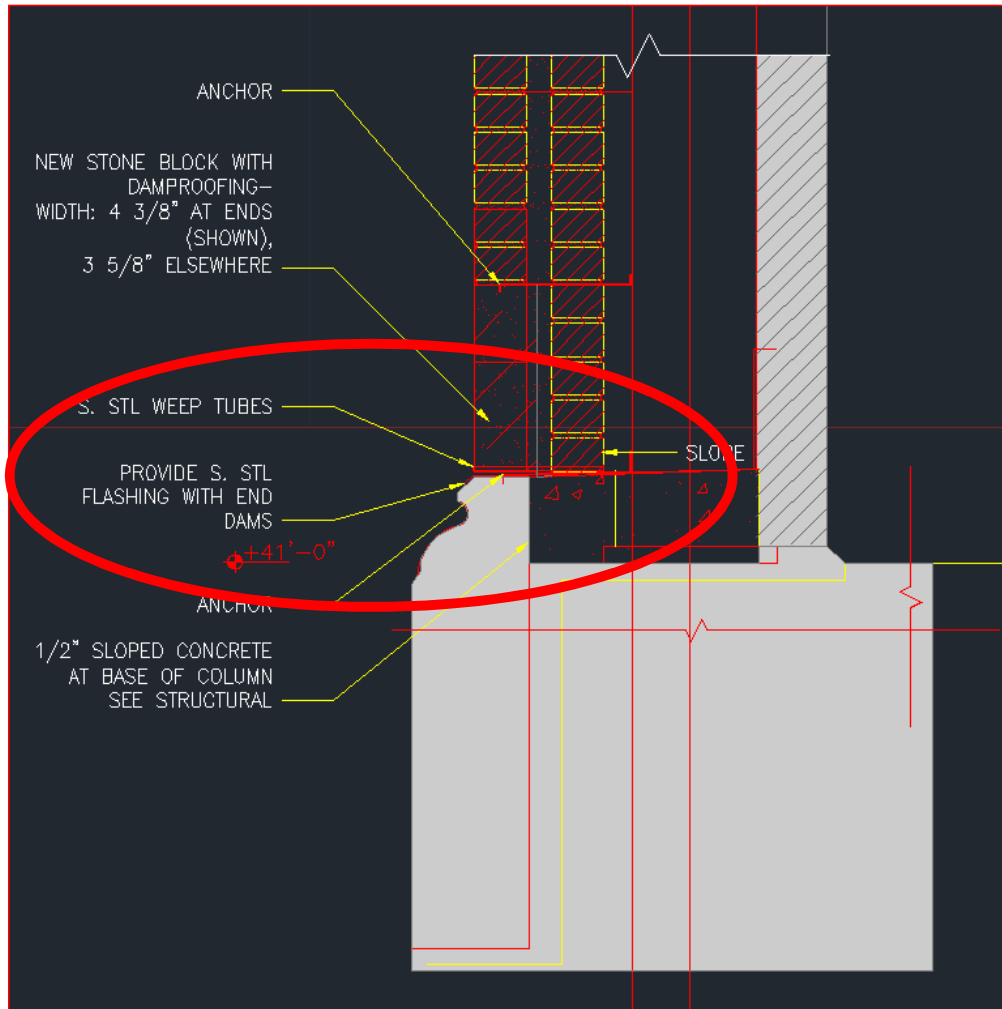
The existing spandrel beams and columns became severely corroded because the original masonry construction did not allow a pathway for water infiltration to escape. The beams and columns were completely encapsulated in masonry which trapped moisture on to the steel surfaces, causing it to corrode. After the masonry is removed for this change order, new masonry will be installed with masonry ties which will leave open space around the beams and columns. Water infiltration will flow through this open space and will be directed out of the wall cavity by stainless steel flashing and weep holes. Therefore, the beams and columns will no longer be in such a corrosive environment

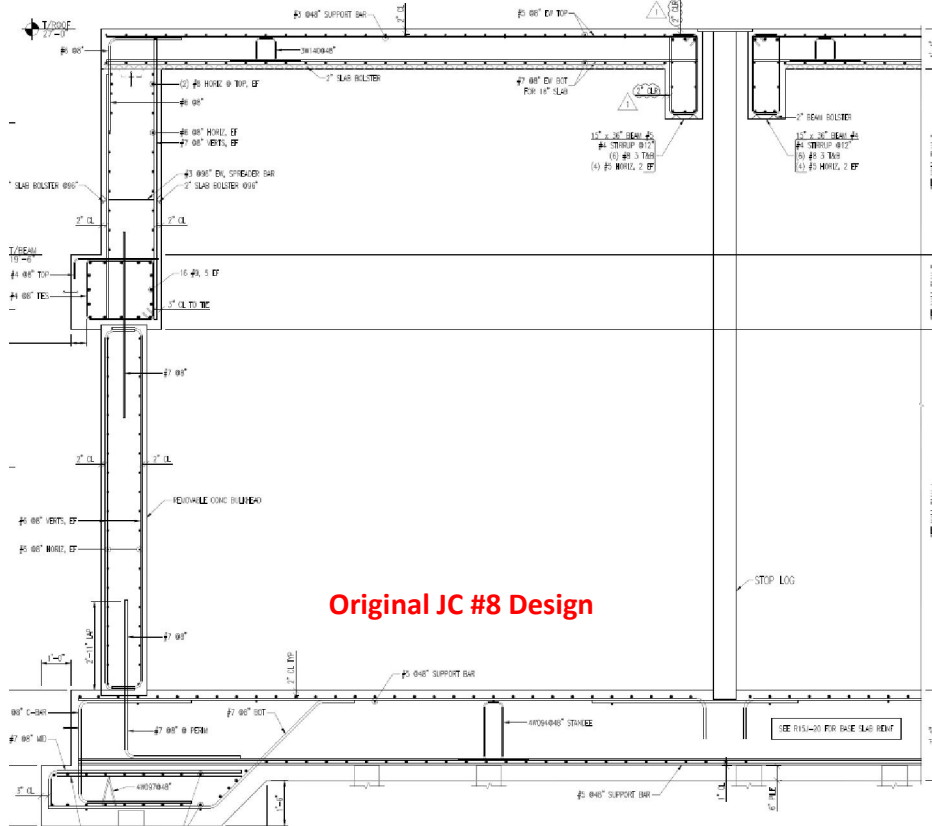
**Original JC #8 Design**

When designing the Junction Chambers, the top elevation of the roof slabs of the chambers was based on normal operating conditions. However, under very high-flow conditions, the District restricts flow from the Westside plant to the Southwest plant. Under this condition, sewage water elevations will be higher than normal conditions and will overflow Junction Chambers 1,4,5,6, & 8. Therefore, the elevations of these chambers must be raised.
