## West Side Fine Screens Building

The Fine Screens building at West Side was constructed in 1928, and is essential for operation of the Stickney WRP. It is a steel-frame building with masonry cladding. The District has invested substantial capitol funds into this building recently, including new sewage screens, new HVAC units, and a new roof and skylights.

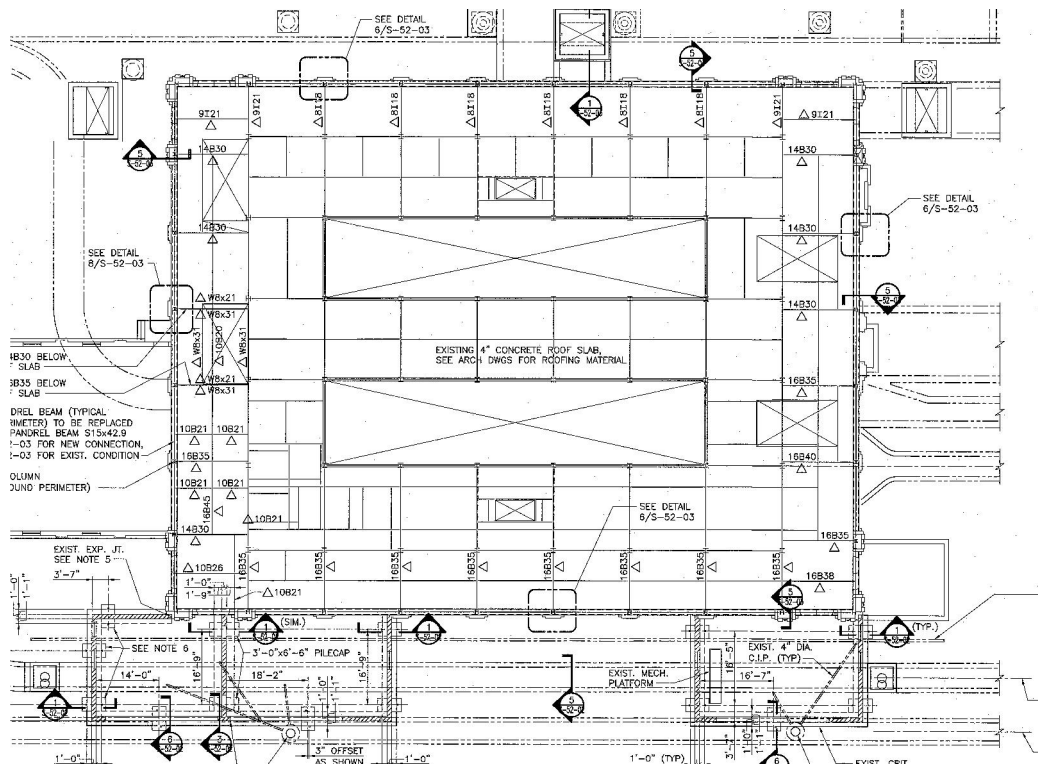
## WS Screen Building Layout

The Screen Building has 32 steel columns on the exterior walls. Masonry must be removed from each pilaster to inspect the column behind.

- If the inspection indicates the column is in good condition, it will be cleaned and painted to prevent corrosion and the brick replaced.
- If the column requires repair, it will be cleaned, reinforced with new steel, painted, and the brick replaced.

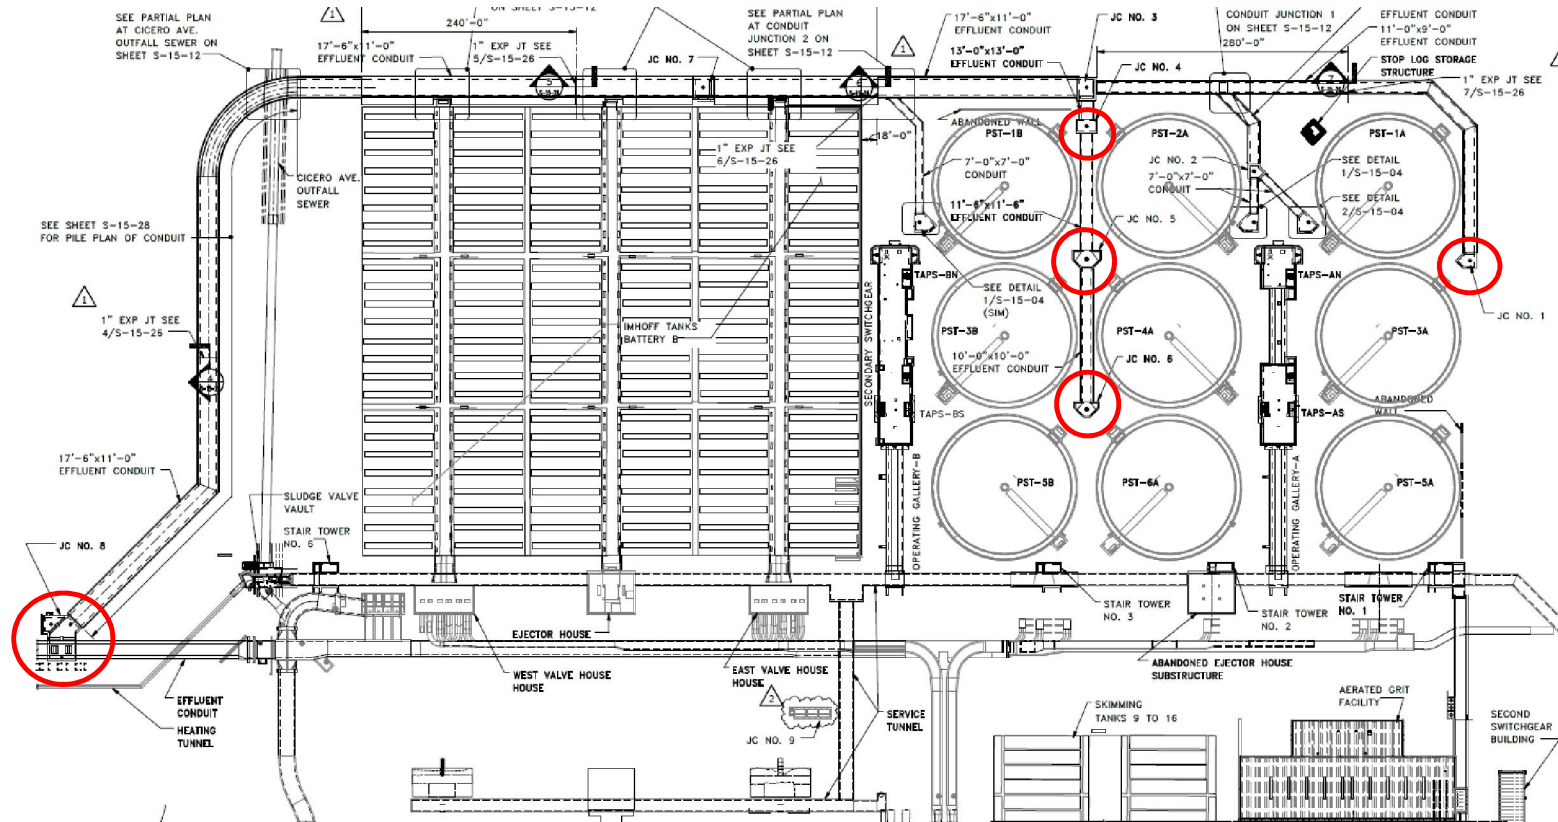
## Change Order 070 – Revising Junction Chambers for Overflow Conditions

When designing the Junction Chambers, the top elevation of the roof slabs of the chambers was based on normal operating conditions. However, under very high-flow conditions, the District restricts flow from the Westside plant to the Southwest plant. Under this condition, sewage water elevations will be higher than normal conditions and will overflow Junction Chambers 1,4,5,6, & 8. Therefore, the elevations of these chambers must be raised.

For Junction Chamber 8, it is required to increase the height of the two-foot thick reinforced concrete walls and the stop logs by 4'. For the other JC's, the precast barrel sections on top of the roof slabs will be replaced by a water tight cast in place concrete barrel section with dowels and hydrophilic waterstops.
